**Clark Fork River  
Operable Unit of the  
Milltown Reservoir  
Clark Fork River  
Superfund Site**

**June 2009**

Soil Sampling at Deer Lodge Trestle, October 2008

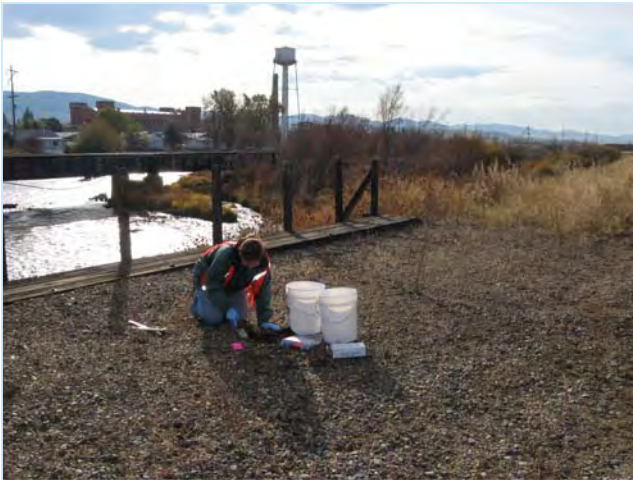
During the week of October 20, 2008, the Montana Department of Environmental Quality (DEQ) conducted soil sampling and survey work in the Trestle Area of Deer Lodge, Montana. Objectives of the Trestle Area sampling consisted of: i) identifying areas of arsenic contamination above human health action levels on and around the trestle, ii) identifying slickens areas and estimating removal volumes for those areas identified for removal by a 2007 EPA study (Riparian Evaluation System, or RipES study), iii) characterizing and evaluating the stream banks within the Trestle Area for remedial action, iv) evaluating the structural stability of the trestle relative to adjacent removals, and v) collecting necessary data to determine and support a remedial design if a human health response action is required. The data will be interpreted to assess risk to human health within the context of expected land use and used to develop any proposed response action.

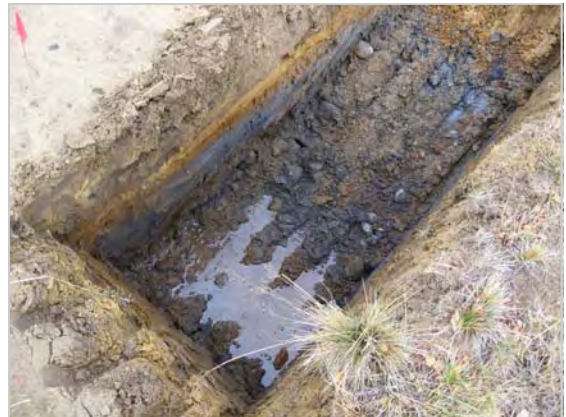
Soil Sampling Pit Showing Visible Contamination at Depth

Two slickens areas were identified by the 2007 EPA study on the north bank of the Trestle Area.

Based on square footage information obtained from the study data and depth information obtained from the October 2008 sampling, the total removal volume for both areas is estimated to be approximately 600 cubic yards.

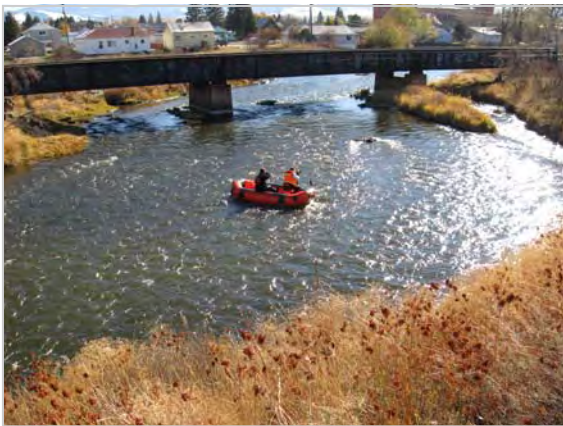
Structural integrity of the two trestles was visually assessed and found to be adequate for current uses. Any remedial activities that occur at this site should be designed such that scour at the bridge pilings is not increased. Geomorphic (river) conditions in the project area were surveyed and recorded. Five areas of stream bank erosion were found, four of which are active, and one of which is severe. Topographic (surface features) survey information was collected throughout the Trestle Area, and cross-sections of the river were surveyed.

Cross-Section River Surveying, October 2008
