Weekly Update

Milltown Reservoir Sediments Superfund Site

Issue #20

June 20, 2007

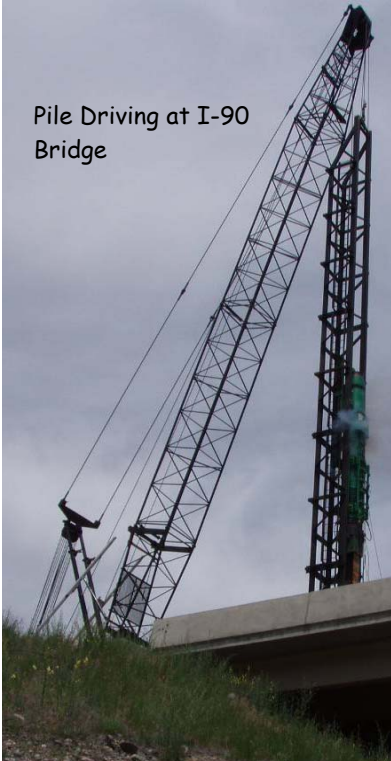
Pile Driving at I-90 Bridge

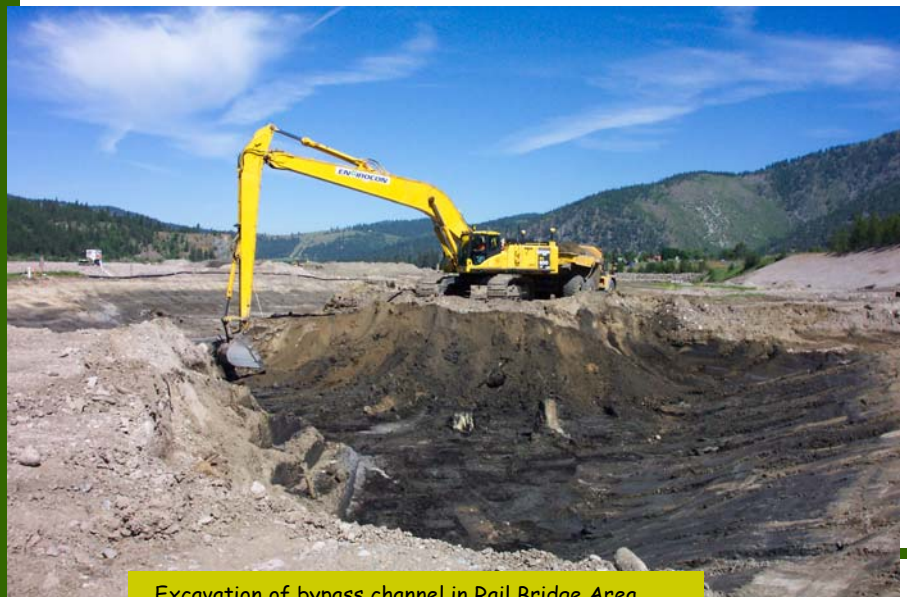
Excavation of bypass channel in Rail Bridge Area

- Excavation of the **bypass channel** continues, removing on average 5500 cubic yards (yd³) per day. Workers are now digging in two locations. Workers continue to expand the footprint of the test pit, moving to the east. Now workers have also begun digging to the east where the rail road bridge will go in over the bypass channel. To date, over 150,000 yd³ have been removed (about 25% of the total bypass excavation volume.) By the time the bypass channel is finished in late September 2007, more than 600,000 yd³ of material will have been removed. The excavated material will be sent by rail to the Anaconda Smelter Superfund Site waste repository beginning in September 2007.

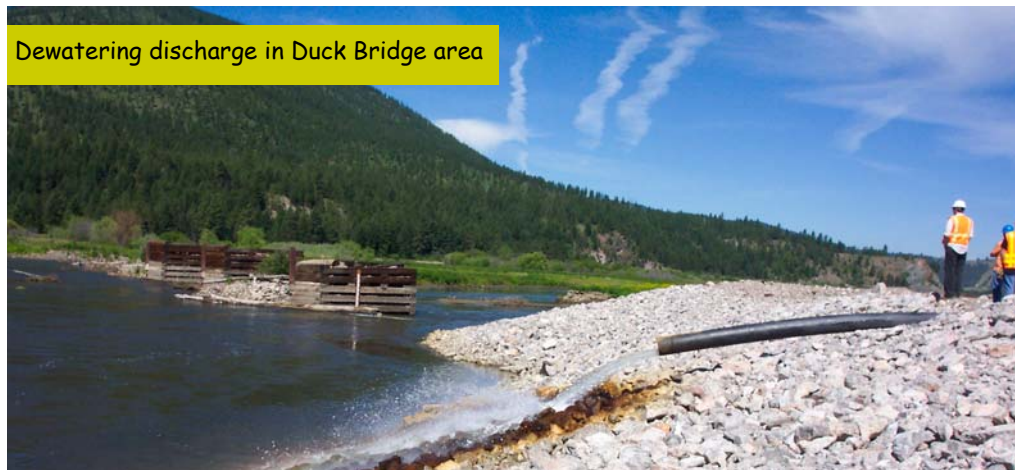
Dewatering discharge in Duck Bridge area

Currently about 3000 gpm of water is being pumped to de-water the bypass channel, much of it in the Duck Bridge area.

It is expected that this pump rate will reach 3500-4000 gpm. This pumping may have dried up 2 shallow (13' and 17') hand-dug wells in the Piltzville area. New, deeper wells have been installed by EPA contractors, to replace the hand-dug wells.
